Upper Section of Stillmeadow Drive Stream Restoration Project: Existing Conditions

Roxbury Court Project Site: Existing Conditions

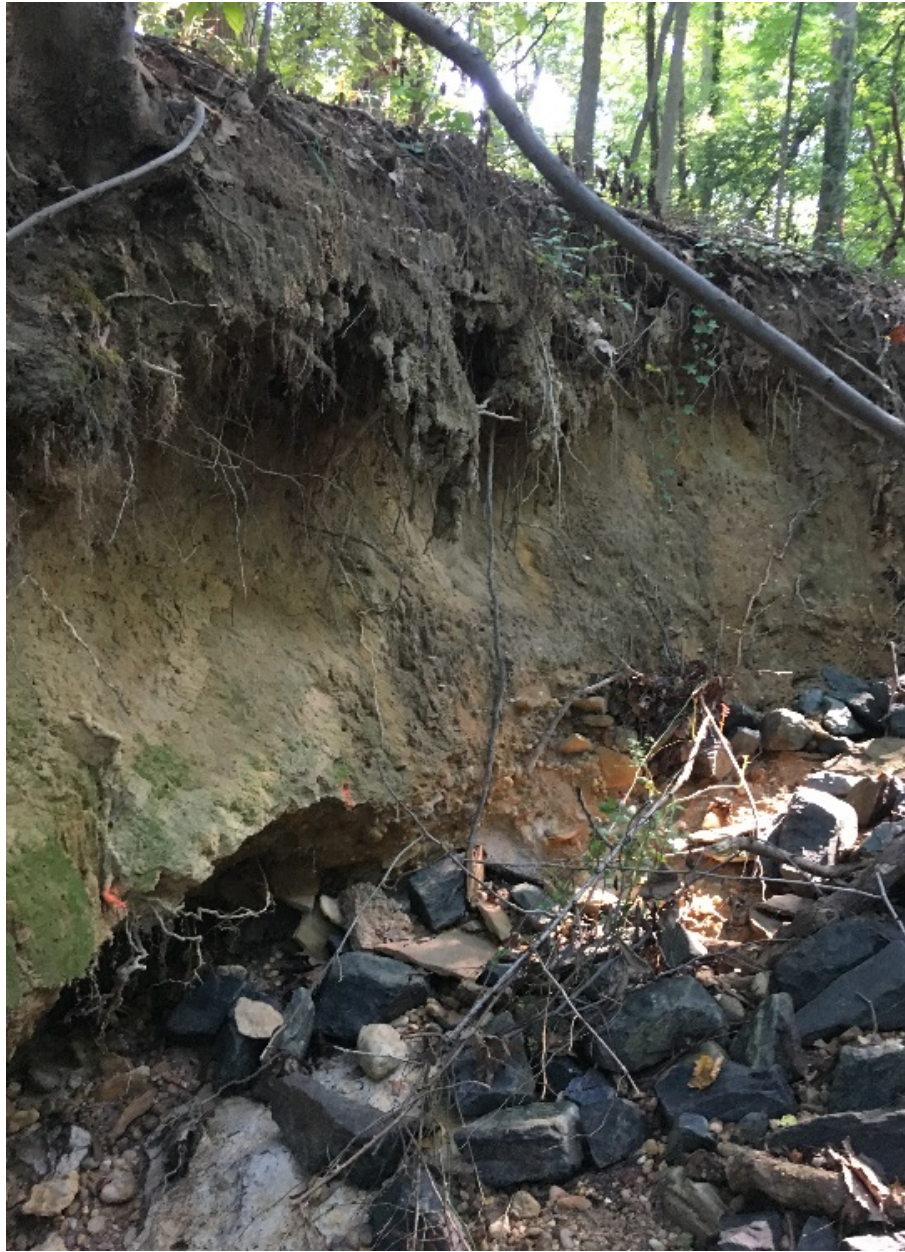
Photo 1: Twelve foot high eroded bank that is beginning to undercut.

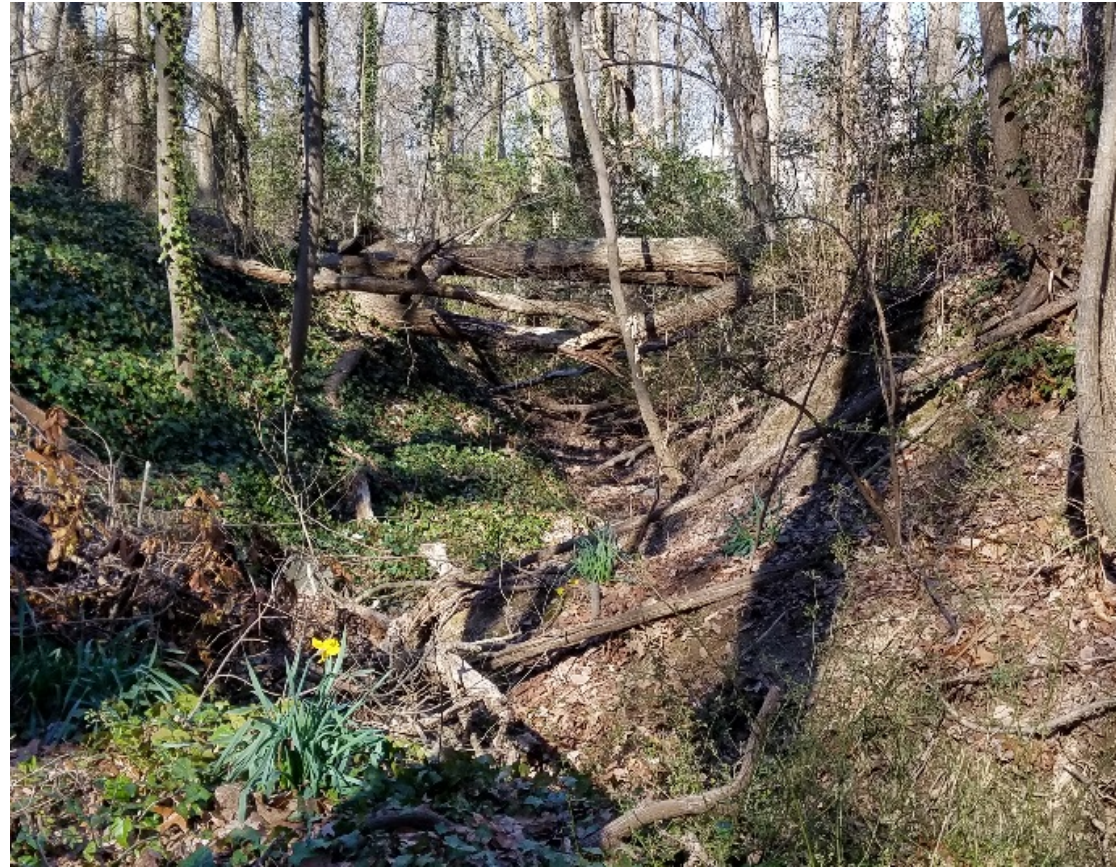
Photo 2: Erosion has caused large trees to fall within the channel; resulting in channel blockages and debris jams.

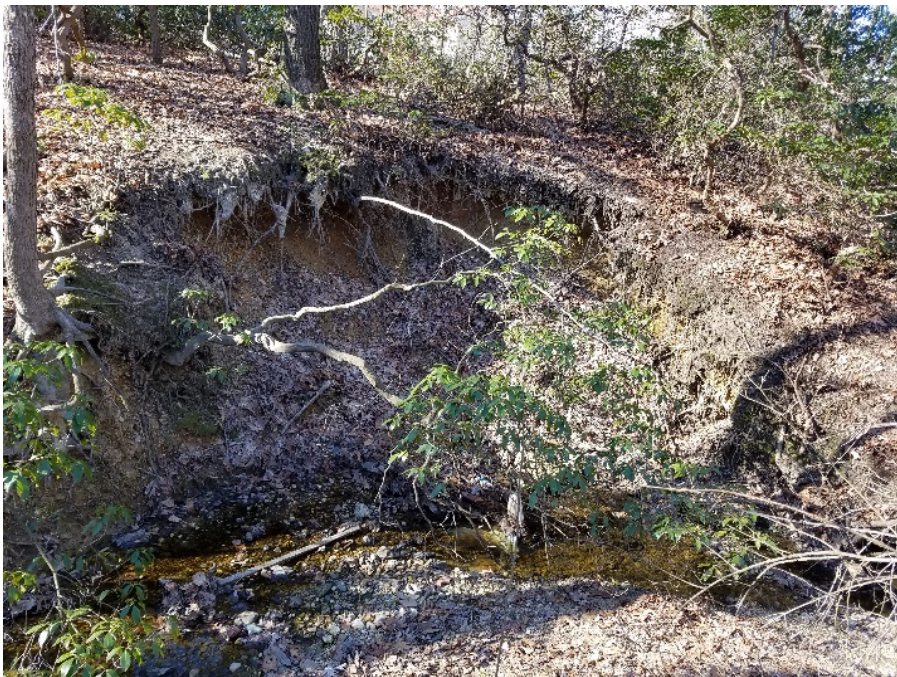
Photo 3: Lateral Bank Erosion

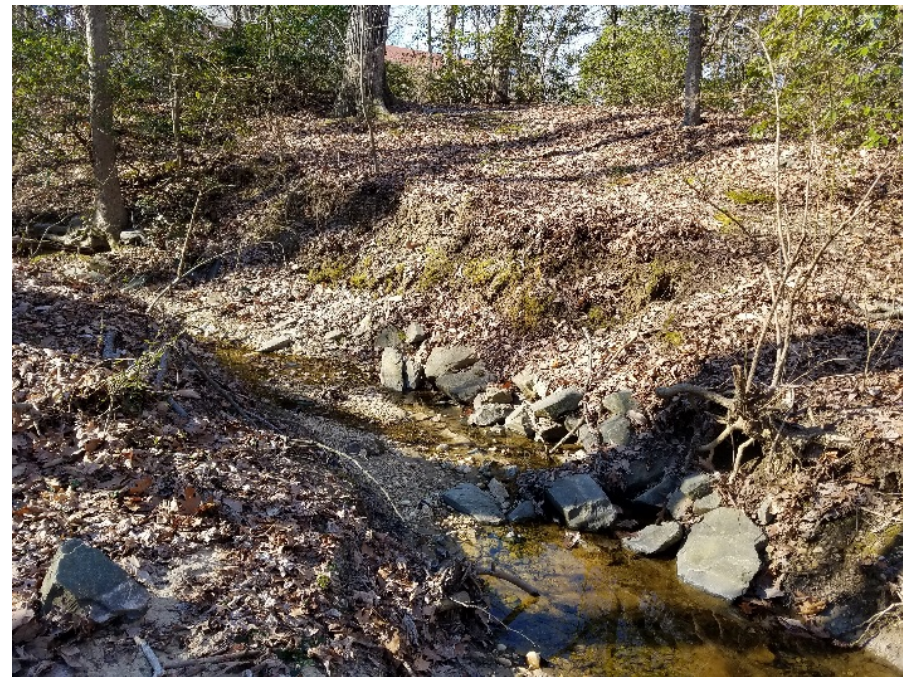
Photo 4: Failed riprap stabilization

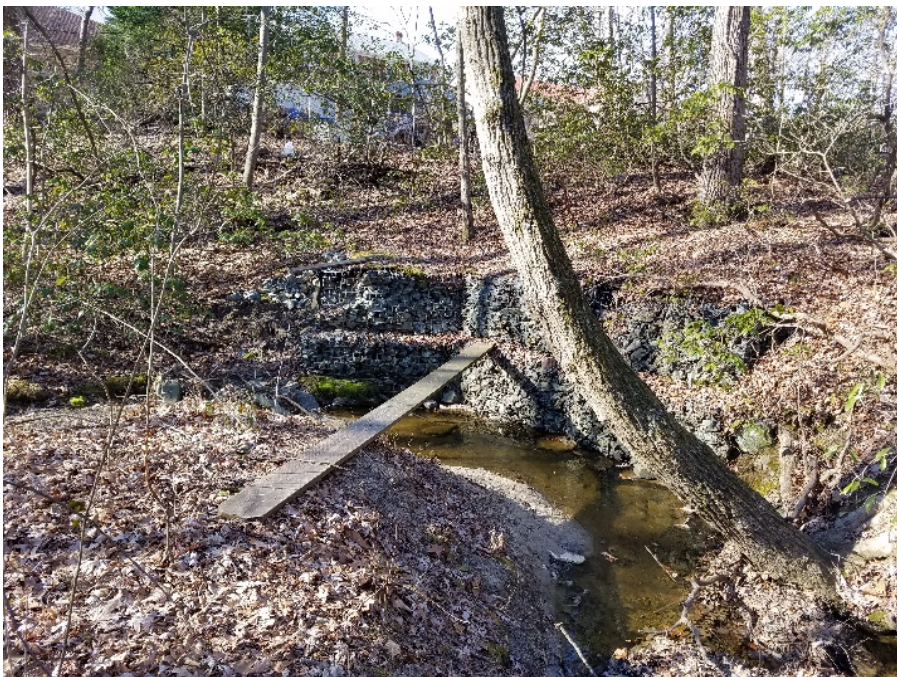
Photo 5: Gabion basket bank protection

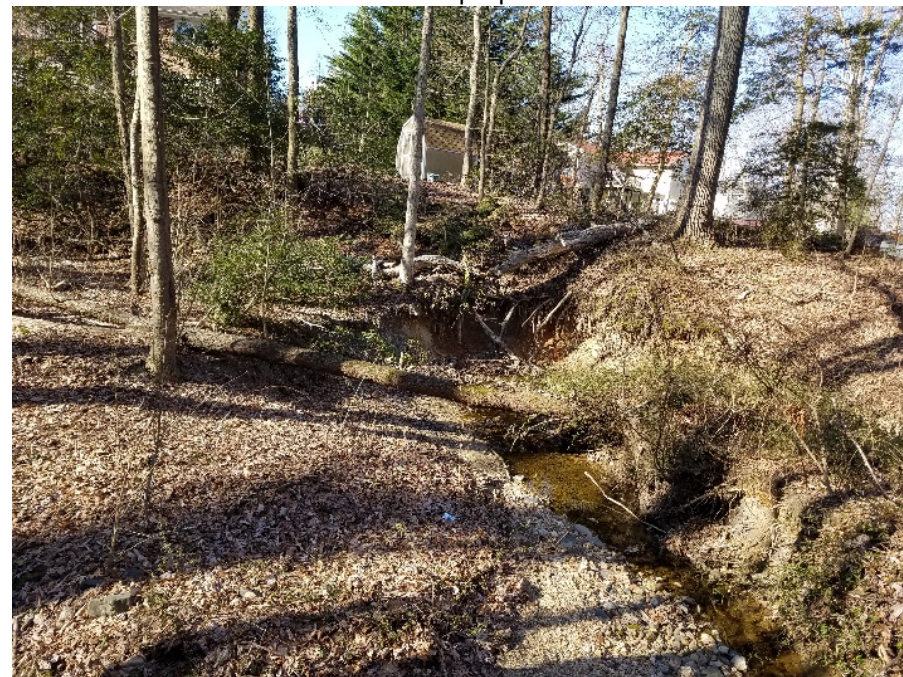
Photo 6: Tree failure due to lateral erosion

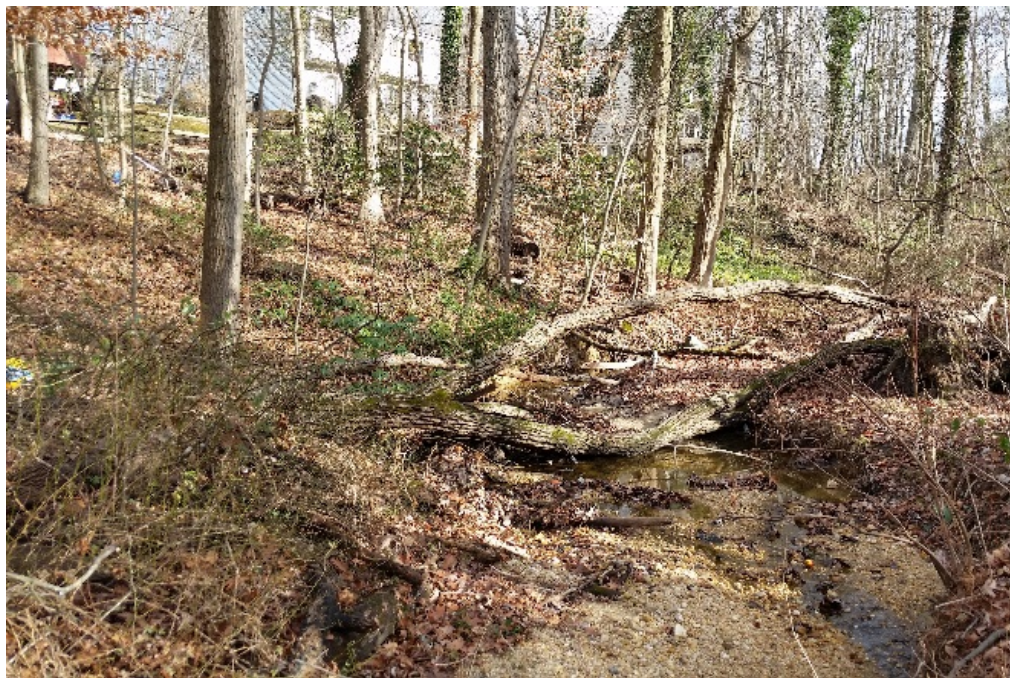
Photo 7: Sediment deposition and tree failure

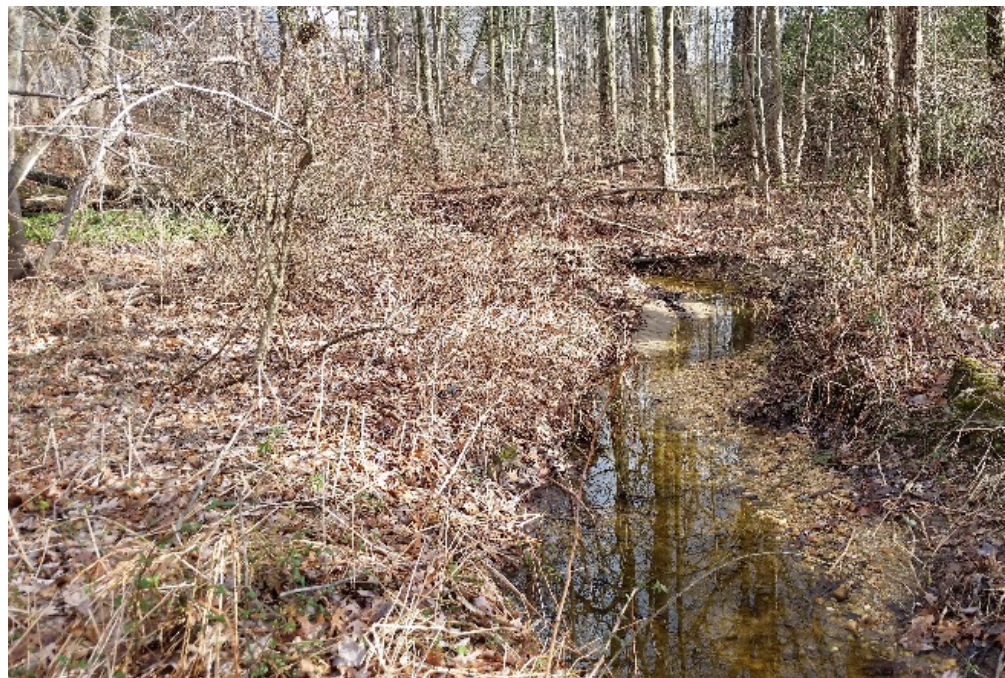
Photo 8: Stable channel at downstream end of project

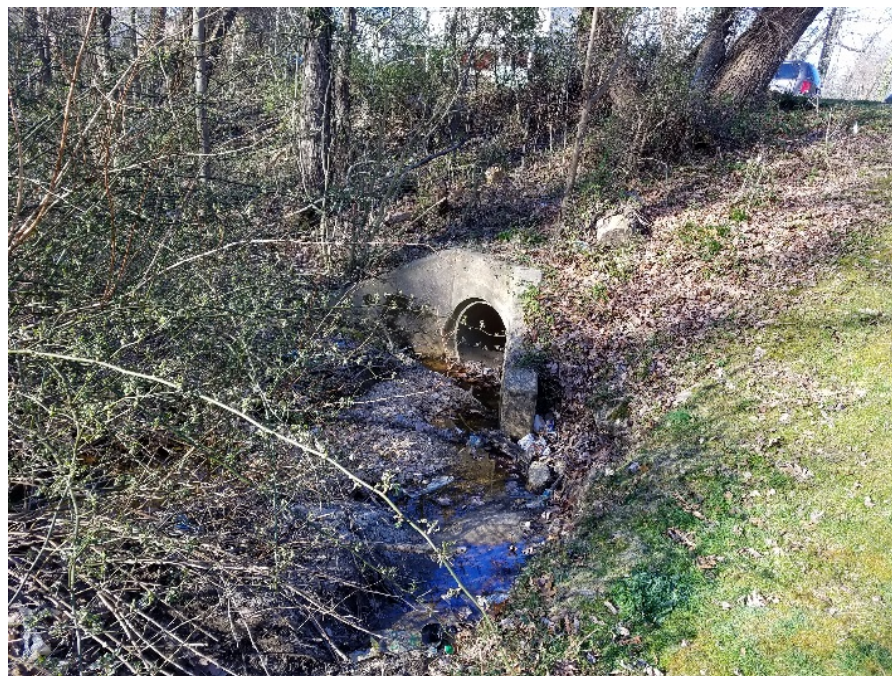
Photo 9: Existing 33-inch concrete culvert beneath Foster Knoll Drive

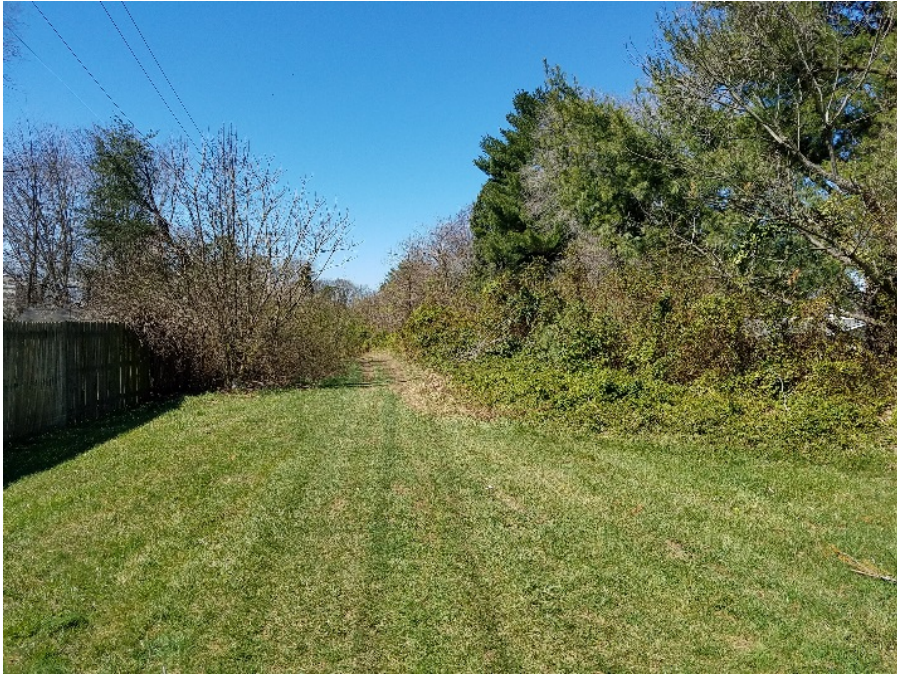
Photo 10: Electrical Transmission Right-of-Way

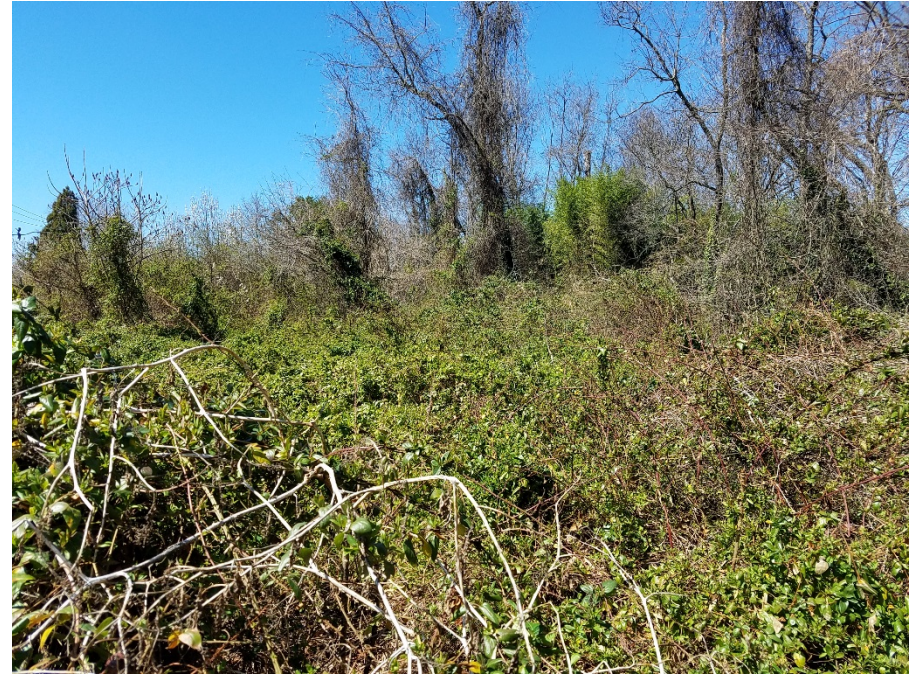
Photo 11: Dense vegetation at project site

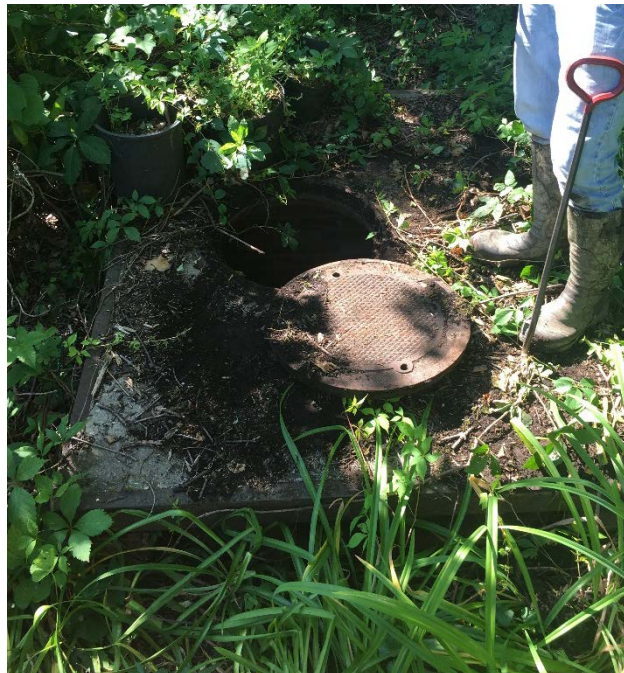
Photo 12: Existing inlet near intersection of Roxbury Court and Blackburn Court
